# Technical report

## A-001/2021

Accident on 12 January 2021, involving a SOCATA TB-10 aircraft operated by Adventia European Aviation College S.A., registration EC-FTJ, at Salamanca Airport (Spain)

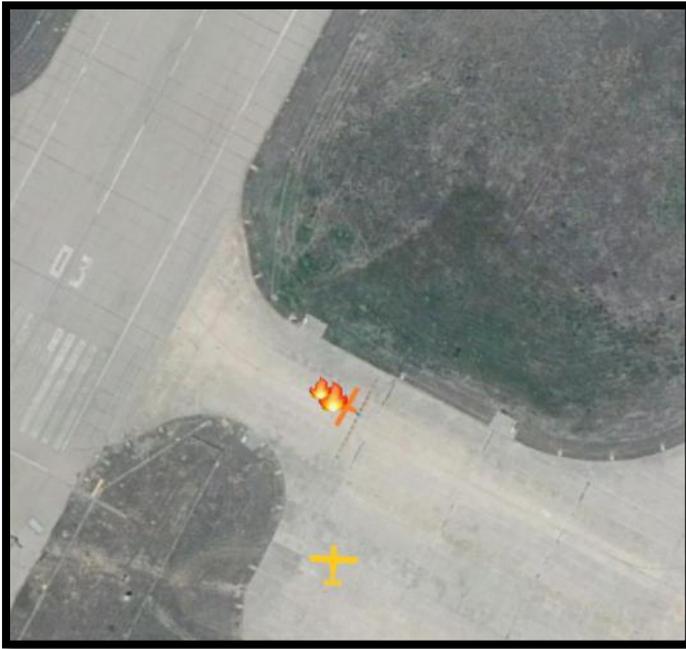
*Figure 8: Wait at C5.*

In the interview, the student pilot stated that he had kept the brakes applied while waiting without noticing any malfunction.

While waiting at the C5 holding point with the brakes applied, the student pilot stated that he heard a message over the radio indicating that the EC-FTJ aircraft was on fire. This message came from the student pilot of an aircraft waiting in the C5 taxiway holding bay for the student pilot of the EC-FTJ aircraft to leave the runway so he could take off.

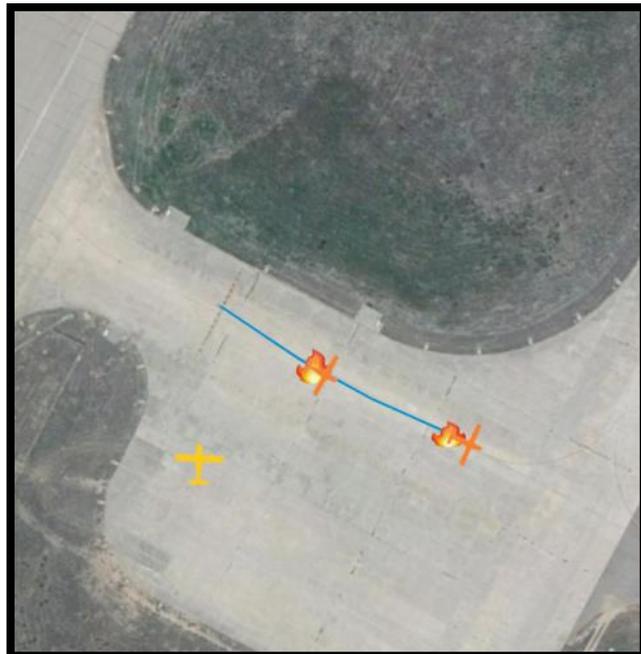
*Figure 9: Uncontrolled taxi on C5.*

According to the GPS trace, approximately 1 minute and 15 seconds after the aircraft came to a stop at the holding point for taxiway C5, it moved about 80 metres in a straight line before coming to a complete stop at the end of said taxiway, where moments later it was attended to by the SSEI.

It should be noted that, in the interview, the student pilot stated that while he was managing the emergency, the brakes suddenly released, and when he tried to apply them, they did not respond. As a result, the aircraft began to roll forward in an uncontrolled taxi before stopping on its own.

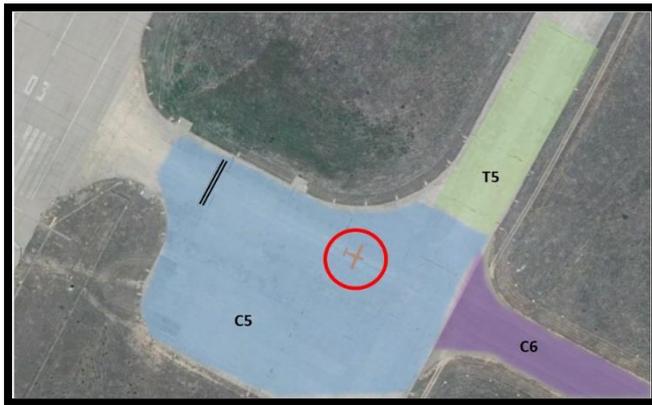
When the firefighters arrived on the scene to extinguish the fire, the aircraft was stationary at the end of taxiway C5, approximately 80 metres from the holding point.

Once the firefighters had extinguished the fire, the left wheel fairing was removed as part of it was stuck to the wheel, preventing the aircraft from being towed.

The fire caused significant damage to the brakes, the tyre, and the left main landing gear leg and fairing.
