Report

A-002/2019

Accident involving a PIPER PA-28R-201 (Arrow III) aircraft, registration G-OARI, on Mount Ernio in Errezil (Gipuzkoa) on 9 January 2019

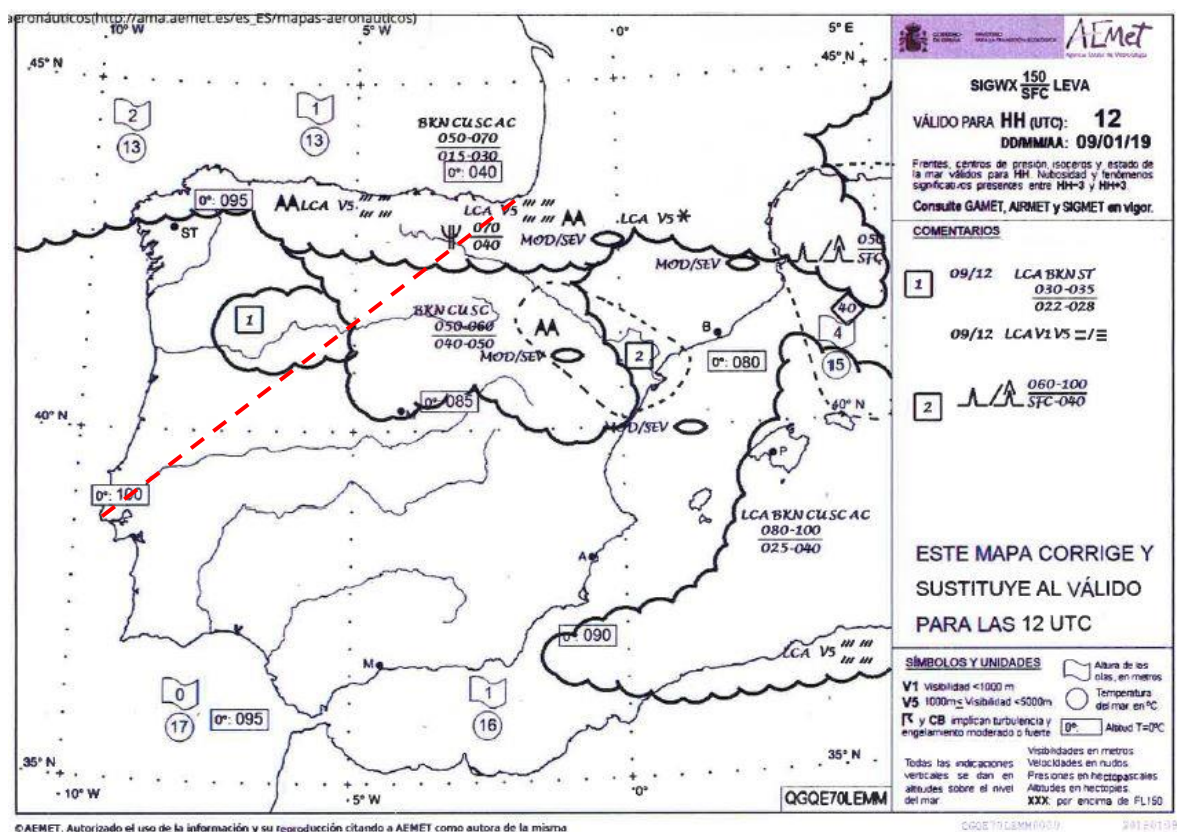
Figure 2. low-level significant weather chart

The only difference between the two maps involved a part of the Mediterranean Sea. Figure 2 shows the SIGWX that replaced the one issued initially. Drawn atop this chart is a dashed

The following weather conditions were forecast for the area where the accident occurred:

The weather forecast from Spain's National Weather Agency (AEMET) for the day of the accident is reflected in the low-level significant weather chart provided in Figure 2.

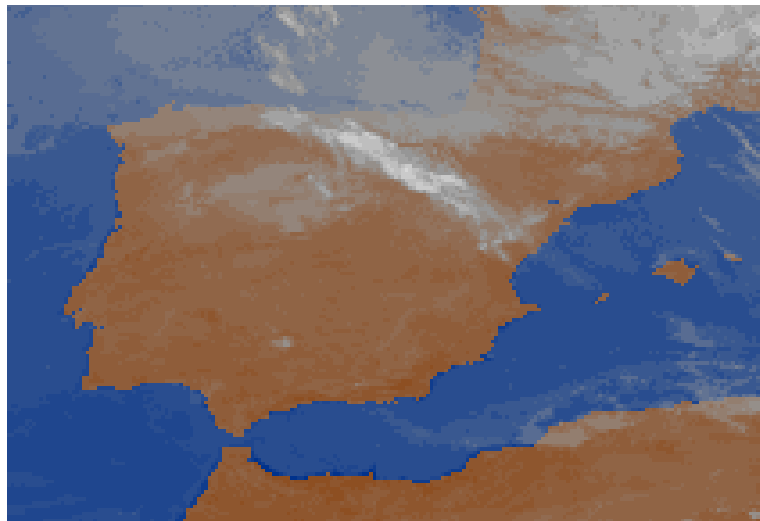
Figure 3. Satellite image from 12:00 UTC

In light of the above data, it may be concluded that the skies in the accident area were practically covered with low clouds with bases at around 1500 feet and tops at 7000 feet, the relative humidity was high and the wind was calm. It drizzled at times in the hours before the accident, which reduced visibility. Although the data from the airports close to the time of the accident were better, it is likely that in some areas, especially at high elevation, there was precipitation. This was the case in Arriarán, though the precipitation was light as it did not produce a radar return. It is also likely that the clouds lingered, especially in medium-elevation mountain summits.

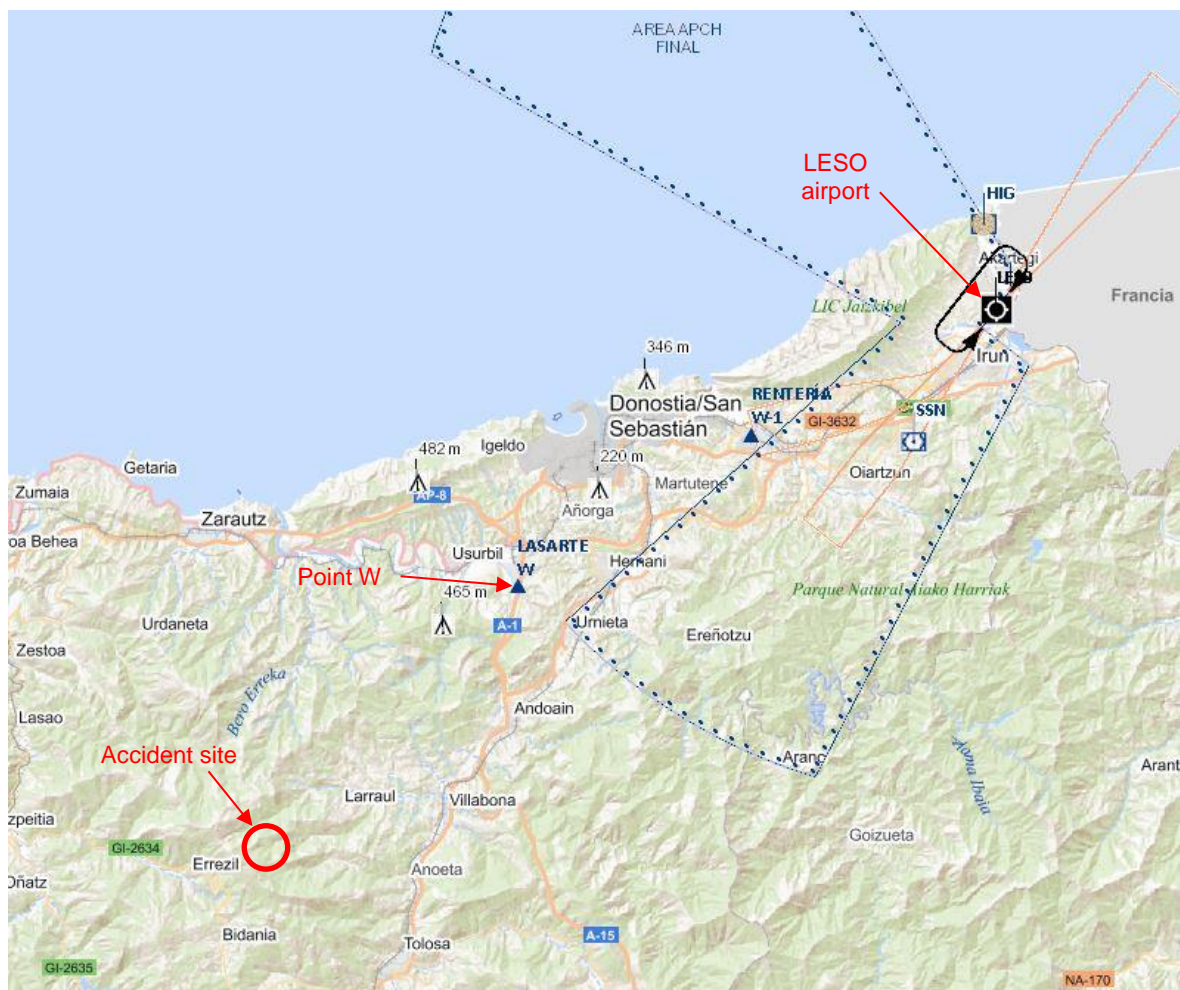
Figure 5. Map showing the accident area and the San Sebastián Airport

Figure 5 contains a section of a map that covers the area from the accident site, circled in red, to the airport of San Sebastian, which is at the top right of the map. The aerodrome circuit is shown with a black line ending in arrows. Reporting point W (Lasarte), where the aircraft was headed, is in approximately the middle of the map.

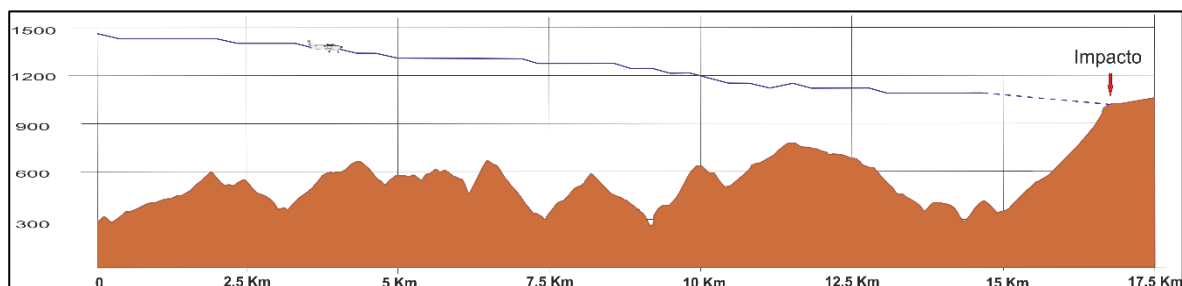
It is important to note that the altitude value is rounded to the nearest hundred feet, meaning the values shown in the table below have a margin of error of ± 100 ft. The 6000 ft value from 12:05:00 corresponds to an actual altitude range of between 5950 and 6050 ft.

Figure 6. Profile of the final part of the flight path, compiled from radar data. The dashed line shows the final part of the flight, for which there are no radar data. The altitude is in meters.

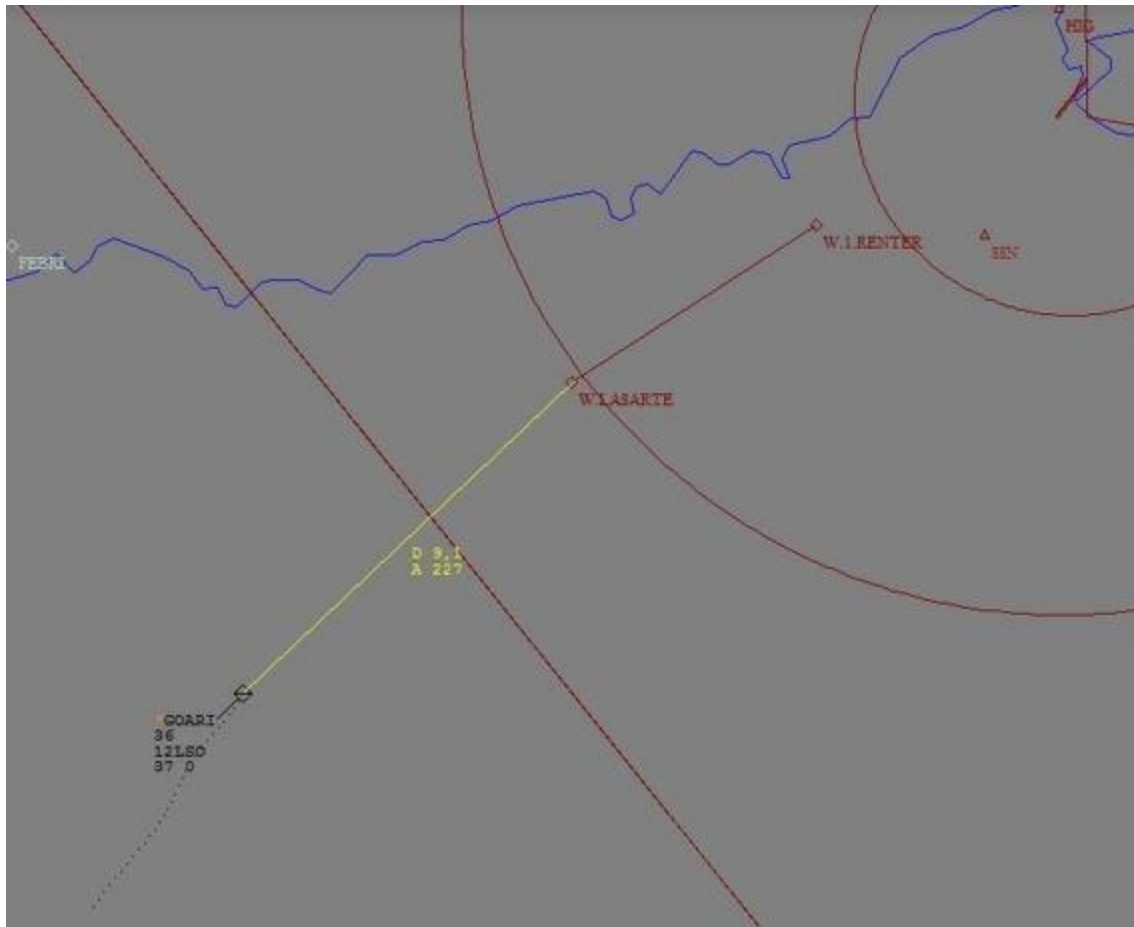
Figure 7 shows a segment of the reconstructed radar data for the last radar return, at which time the aircraft was flying at an altitude of 3600 ft and 120 kn.

Figure 7. Close-up of the reconstructed radar data at 12:13:32 UTC, showing the final radar return.

The dotted black line, which corresponds to the aircraft's radar returns, shows the aircraft's flight path. As we can see, the aircraft was basically flying in a straight line, with some very gradual turns.

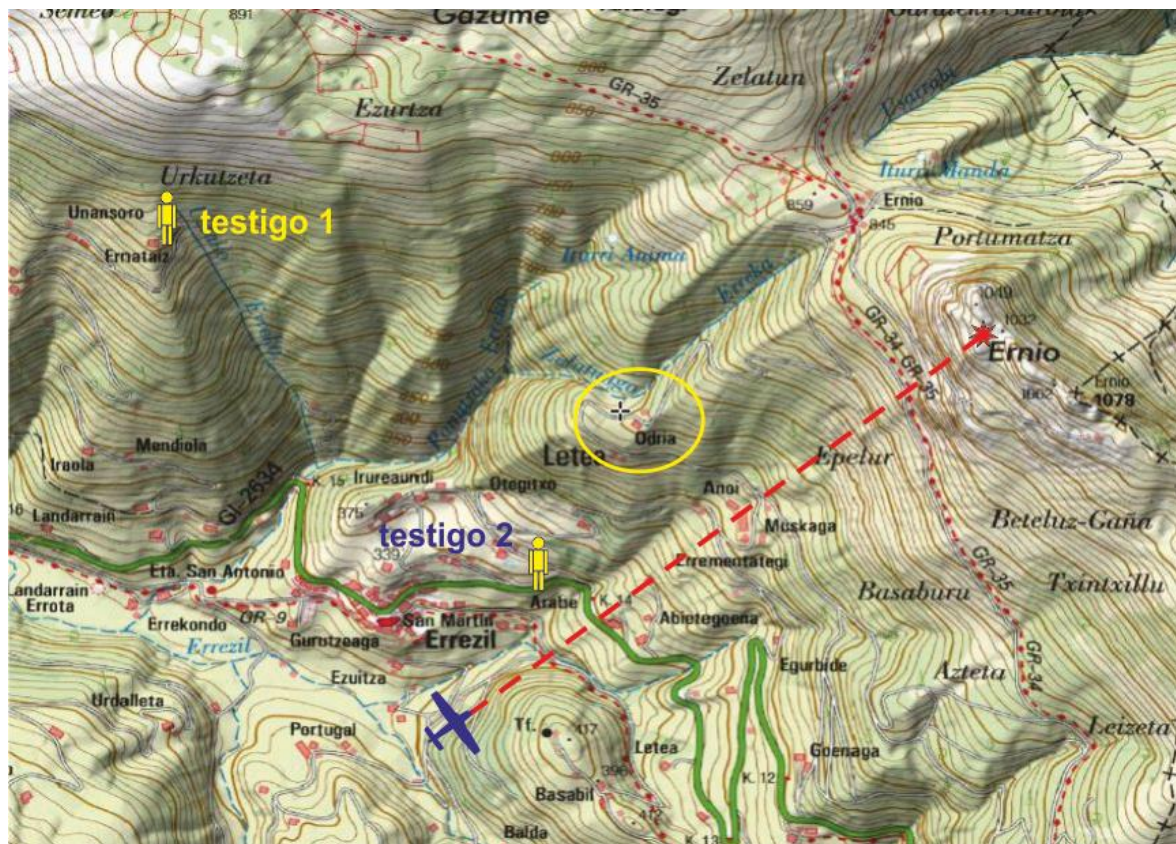
He was engaged in agricultural activities on the hillsides of Mount Urkutzeta (see Figure 11).

This video shows the individual climbing on a trail when, at one point, the sound of an aircraft engine is heard. The individual moves the camera and points it at the sky to record the airplane. This reveals a completely overcast sky. The aircraft is not visible at first; in fact, the audio in the recording contains this individual's voice saying something that sounded like "I can't see it". But at a certain point, lasting less than a second, the airplane does come into view before it is again obscured by the clouds.

The engine is heard for an additional 40 seconds, until something that sounds like an impact is heard.

Figure 11. Contour map of the accident site, showing the location of the eyewitnesses and the Hamlet of Odria, as well as the aircraft's flight path .

The video also showed that despite the abundant clouds, there was no rain for the duration of the recording.
