CIAIAC

Report A-015/2017

Accident involving a Bell 206B3
helicopter, registration D-HHMP,
operated by Rotorsun, in Pego
(Alicante) on 5 August 2017

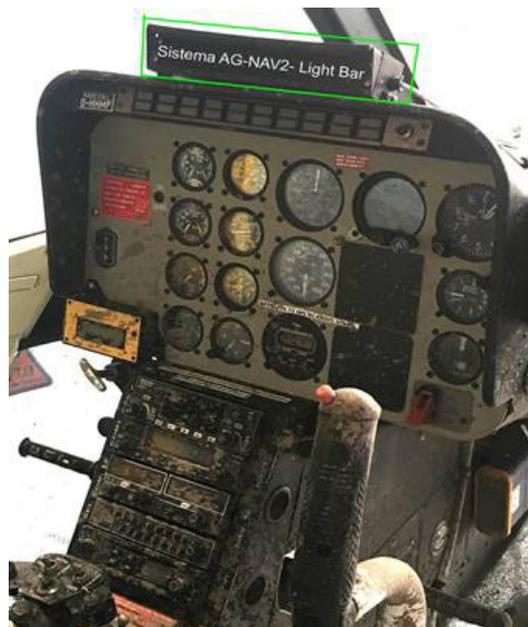
Figure 6. Instrument panel on the Bell 206B and AG-NAV light bar

The light bar on the accident aircraft was located at the top of the glareshield on the instrument panel, as shown in the photograph in Figure 6.
