Report A-018/2020

Accident on 20 June 2020,
involving a TECNAM P2002-JF
aircraft operated by FlyBai,
registration EC-MOH, at Burgos
Airport

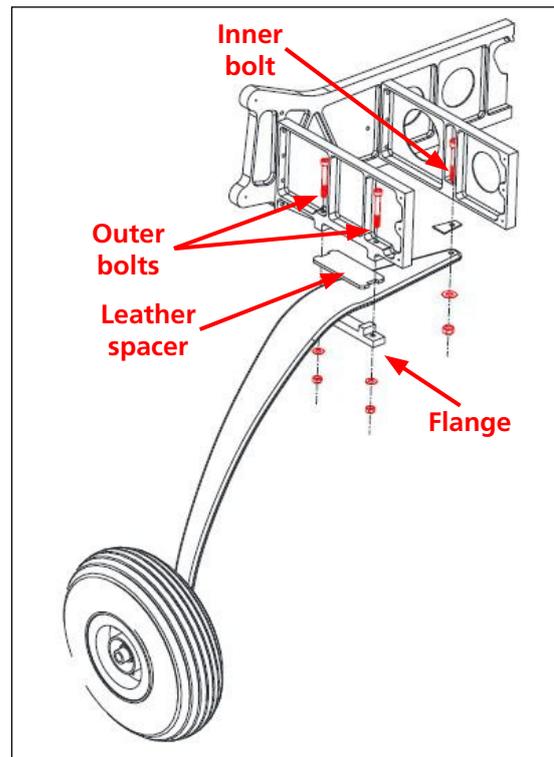
Figure 2. Main landing gear diagram

Figure 2 shows a diagram of one of the legs.

According to the aircraft maintenance manual (P2002JF *Maintenance Manual* Sec.5-20 Edición 2 nº de Rev. 4), in a type A revision (50 h), only one task is performed on the landing gear system (ATA32) to check the correct tightening torque of the main landing gear attachment bolts and replace the leather spacer, if necessary. The *Maintenance Manual* indicates that the tightening torque for the nuts of the outer bolts (AN-365-524A) should be 15 ± 1 Nm, while it should be $25 +3/-2$ Nm for the inner bolts (AN-365-624A).
