**COMISIÓN DE  
INVESTIGACIÓN  
DE ACCIDENTES  
E INCIDENTES DE  
AVIACIÓN CIVIL**

**Report  
A-025/2021**

Accident involving a Boeing 737-8AS aircraft, registration EI-EVE, operated by Ryanair, at Málaga Airport (Málaga, Spain) on 13 June 2021

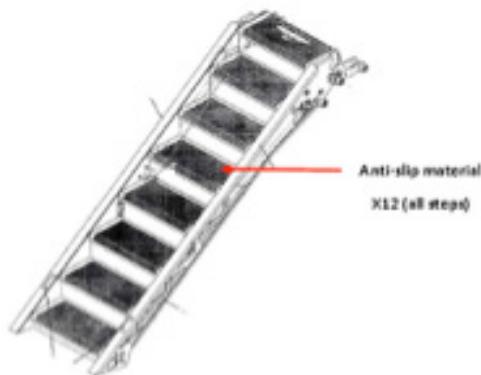
3.- The aircraft involved in this event had warning signs advising that passengers travelling with young children should hold their hands when walking up or down the stairs, as per Special Airworthiness Information Bulletin (SAIB) NM-07-47<sup>6</sup>, issued by the FAA in September 2007. The stairs of the aircraft involved in this event are shown in the photos below. The warning signs are visible on the step risers.
