## Report A-028/2017

Accident involving a PILATUS  
PC6-B2-H2 aircraft, registration  
EC-EMZ, at the aerodrome of  
Empuriabrava (Girona, Spain) on 23  
November 2017

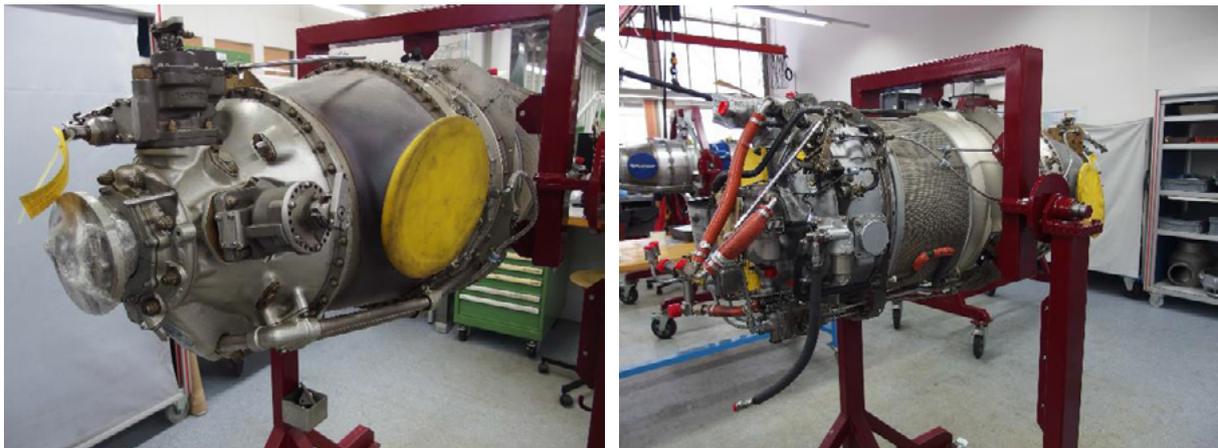
- The engine PCE-RB0104 probably experienced a flameout in flight, meaning the flame in the turbine was extinguished for an unknown reason.
- The engine restart procedure was attempted in flight, and flames were observed in the exhaust stubs. According to the pilot's statement, he was not watching the interturbine temperature indicator whilst the engine relight procedure.
- From these facts, an engine hot start can be highly suspected.
- An emergency landing was made, after which the pilot stated that he stopped the engine.

Based on these facts, and since it was not possible to confirm that the ITT was exceeded, it was decided to send two blades from the compressor turbine to a metallurgical laboratory to verify their structural integrity and check for potential additional damage to the engine, since an excess temperature in the area could have been identified by this laboratory by analyzing the materials.

Photograph 10. Engine on test bench: front view (r.) and rear view (l.)
