Report A-029/2020

Accident on 30 July 2020,
involving a PC-28 CRUISER
operated by FLYBAI, S.L.,
registration EC-NAP, at Burgos
Airport (Villafría-Burgos, Spain)

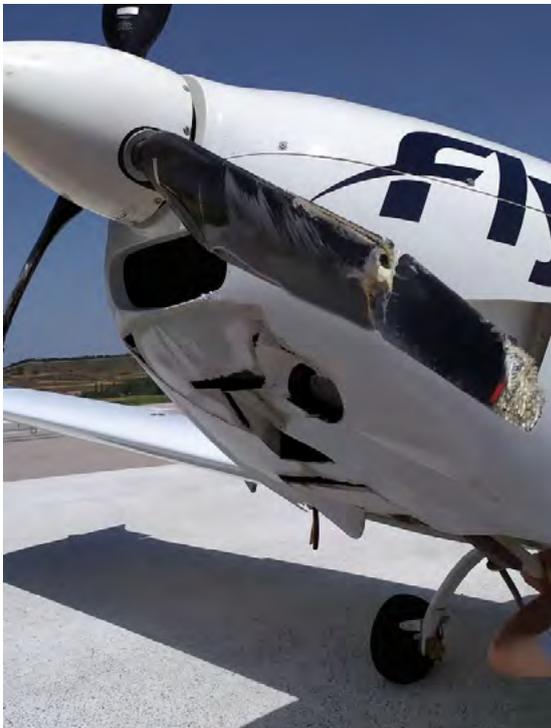
Photograph 1. Accident aircraft

The aircraft sustained significant damage to its nose landing gear, propeller and lower forward fuselage.
