Technical report

A-029/2020

Accident on 30 July 2020,
involving a PC-28 CRUISER
operated by FLYBAI, S.L., registration EC-NAP,
at Burgos Airport
(Villafría-Burgos, Spain)

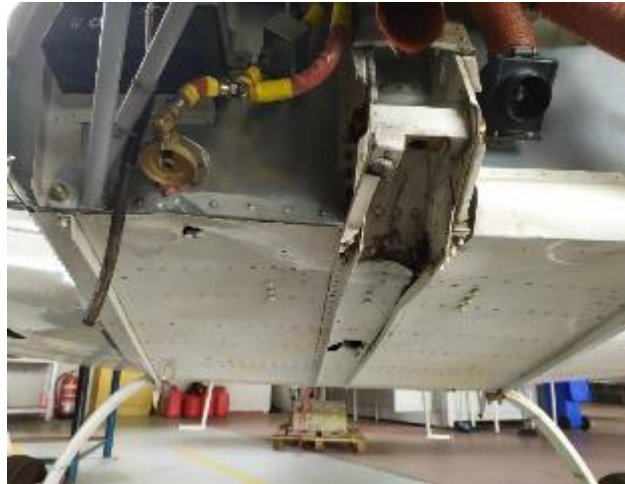
Due to the impact and detachment of the nose wheel, the aircraft's nose dropped onto the runway, causing the following damage:

Photograph 6. Pedal channel
