CIAIAC

Report A-032/2019

Accident on the 19th of July
2019, involving a Piper PA 28-140
aircraft, registration EC-GDC, in
Villarrubia de Santiago (Toledo)

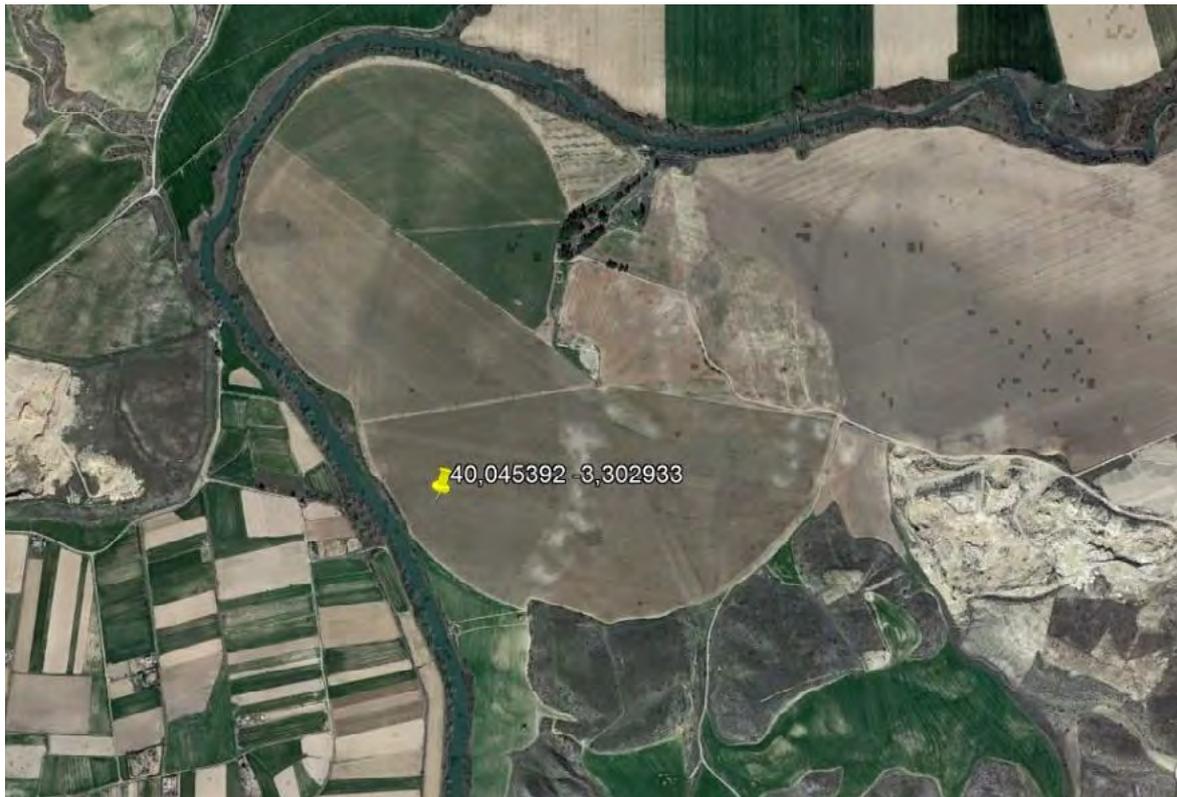
The aircraft made an emergency landing in a cornfield of about 60 Hain the municipality of Villarrubia de Santiago, in the province of Toledo, whose cultivation was around 2 m high.

Photograph 2. Geographical coordinates of the accident site

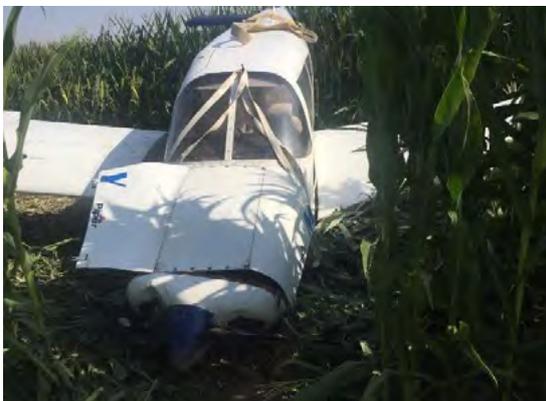
Significant damage to the aircraft, particularly the landing gear, aircraft nose and wings, will occur.

Photograph 3. Aircraft at the accident site

- Deformation and breakage of anchors of the upper engine cowlings. Deformed and eroded propeller.
- Wing deformation and separation of the left fuselage-wing joint.
- Landing gear: the main gear was damaged and deformed and the nose gear destroyed.

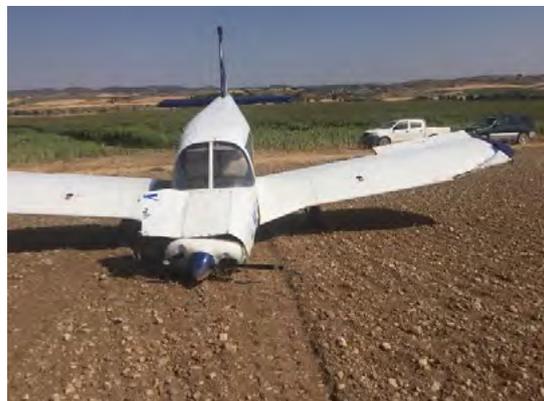
Photograph 4. Aircraft in the field adjacent to the accident site

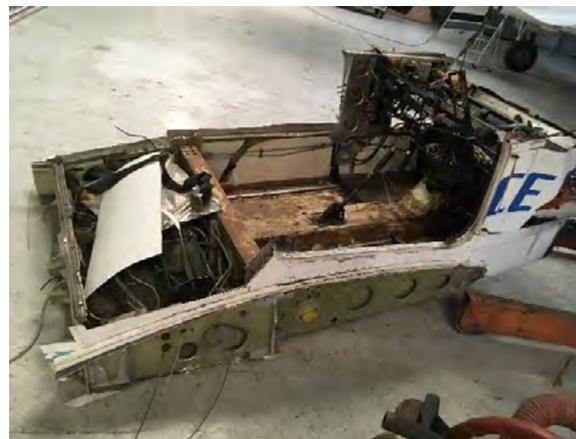
The only remaining part of the cabin was the lower fuselage, without the cover. The indicator panel was missing the instrumentation but did have the power controls.

Photograph 9. Aircraft cabin wreckage

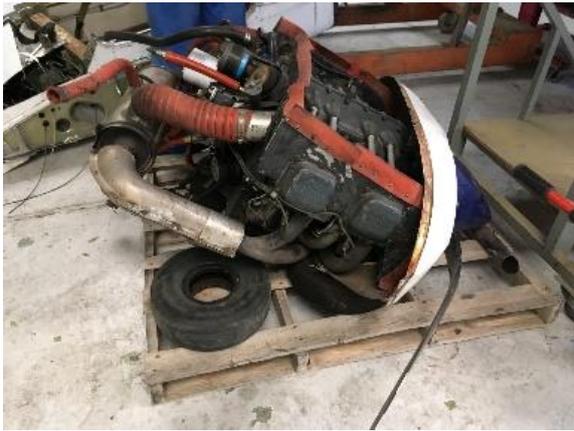
Photograph 10. Engine from the damaged aircraft

- The cylinder compression and operation of the intake and exhaust valves were checked and found to be acceptable in all four cylinders.
- The condition of the spark plugs was also checked. They were found to be new and in good condition except for those of cylinder number 3, where both the upper and lower spark plugs were blackened and had excess oil.

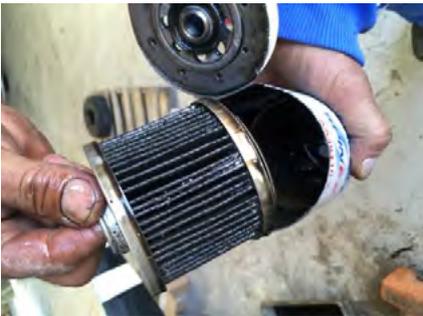
Photograph 18: Oil filter
