Report A-042/2019

Accident involving the aircraft
SPORTINE AVIACIJA LAK 17B FES
18M, registration D-KSEO, on
11 August 2019 at the Garray
aerodrome (Soria)

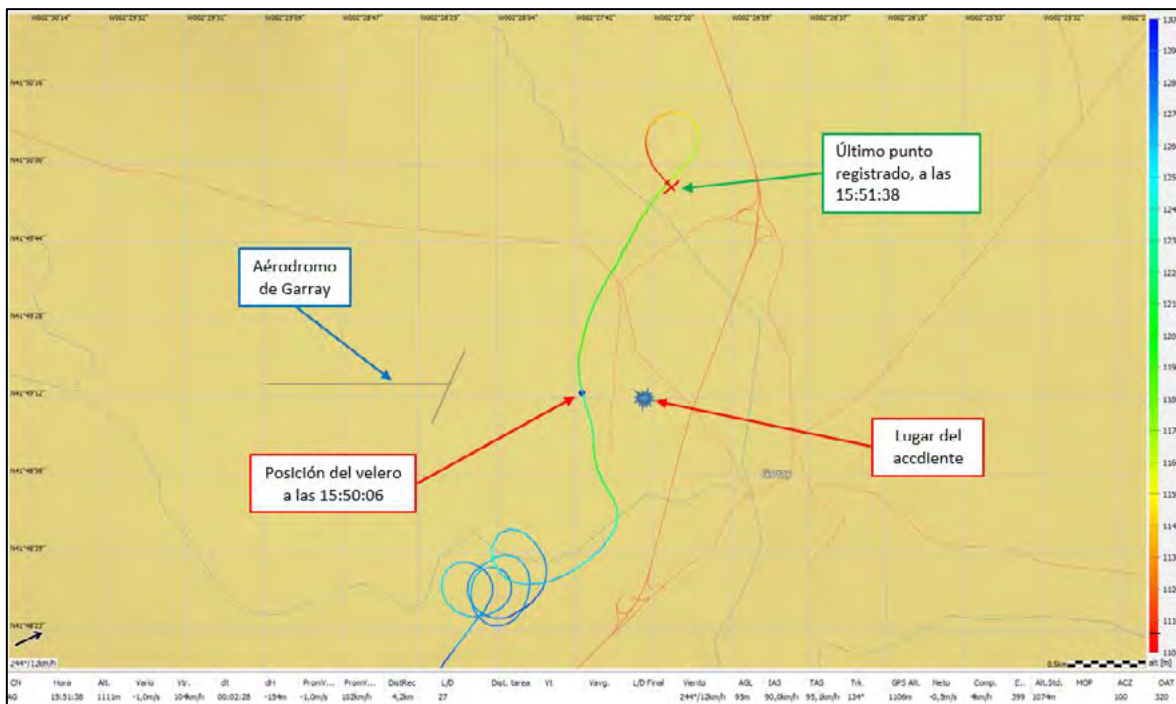
- During the return, the pilot travelled some 40 km of distance in 58 min to the town of Soria in 107 km of flight manoeuvres, continuing to perform the flight in challenging gliding conditions. Given the loss of altitude, with the town of Soria in sight, the pilot activated the electric support motor on four consecutive occasions with a total of two minutes and 44 seconds of use, disconnecting it when the Garray aerodrome came into view.
- At 15:50, the glider crossed the extension of the runway centreline at a distance of 800 m horizontally and about 200 m above it (see Illustration 4). At 15:51:38, when the information from the aircraft's recorder was lost, it was located north of the town of Tardesillas, 1875 m in a straight line from the head of runway 27 and 86 m above it. At that point, it had travelled 275 km in a total time of two hours and 26 minutes.

Illustration 4: Illustration depicting the last movements recorded by the aircraft's avionics
