Report A-043/2019

Accident involving a mid-air collision between a Bell 206 L3 aircraft operated by Roterflug, registration D-HOTT, and an Aeroprakt A22L aircraft, registration EC-GU1, on 25 August 2019 in the vicinity of Inca (Mallorca)

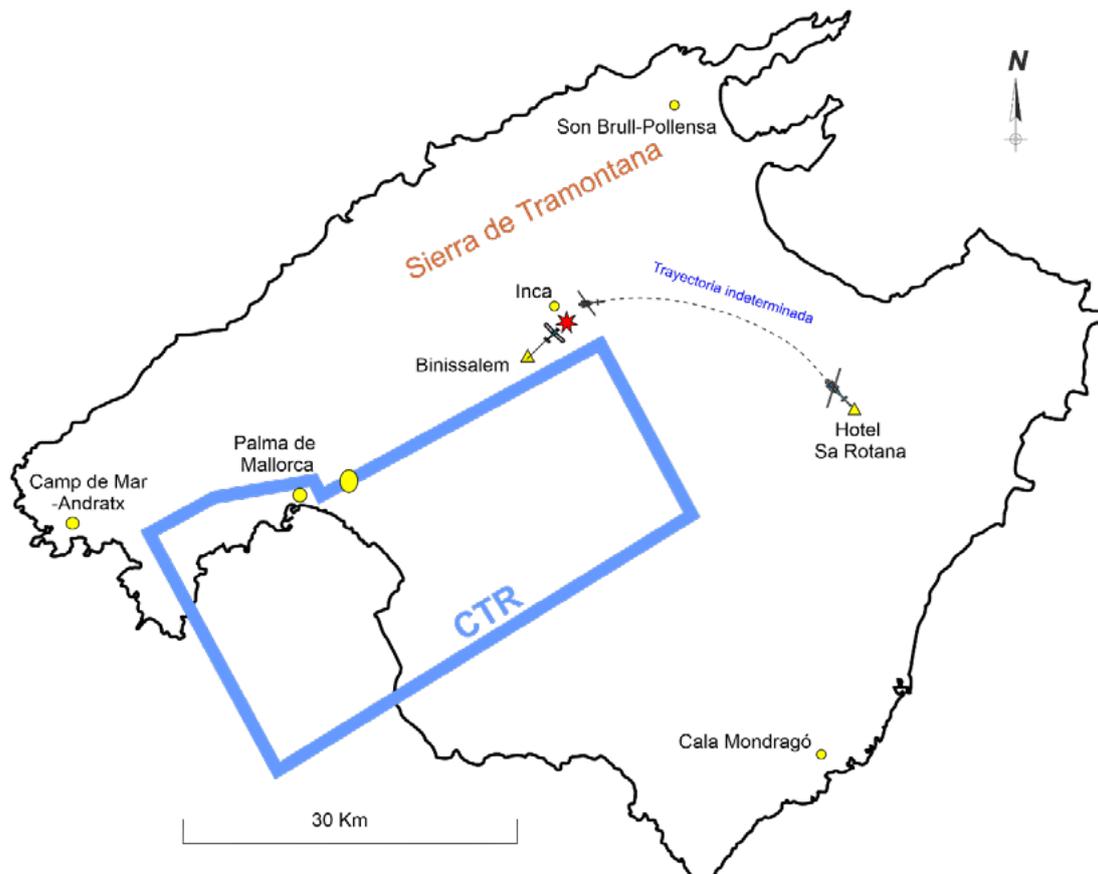
Fig. N°1.- Map of locations and aircraft positions.

A few minutes later, with both aircraft in the cruise phase of their flights and the ultralight to the left of the helicopter (according to the helicopter's direction of travel), their converging trajectories caused them to collide in mid-air.

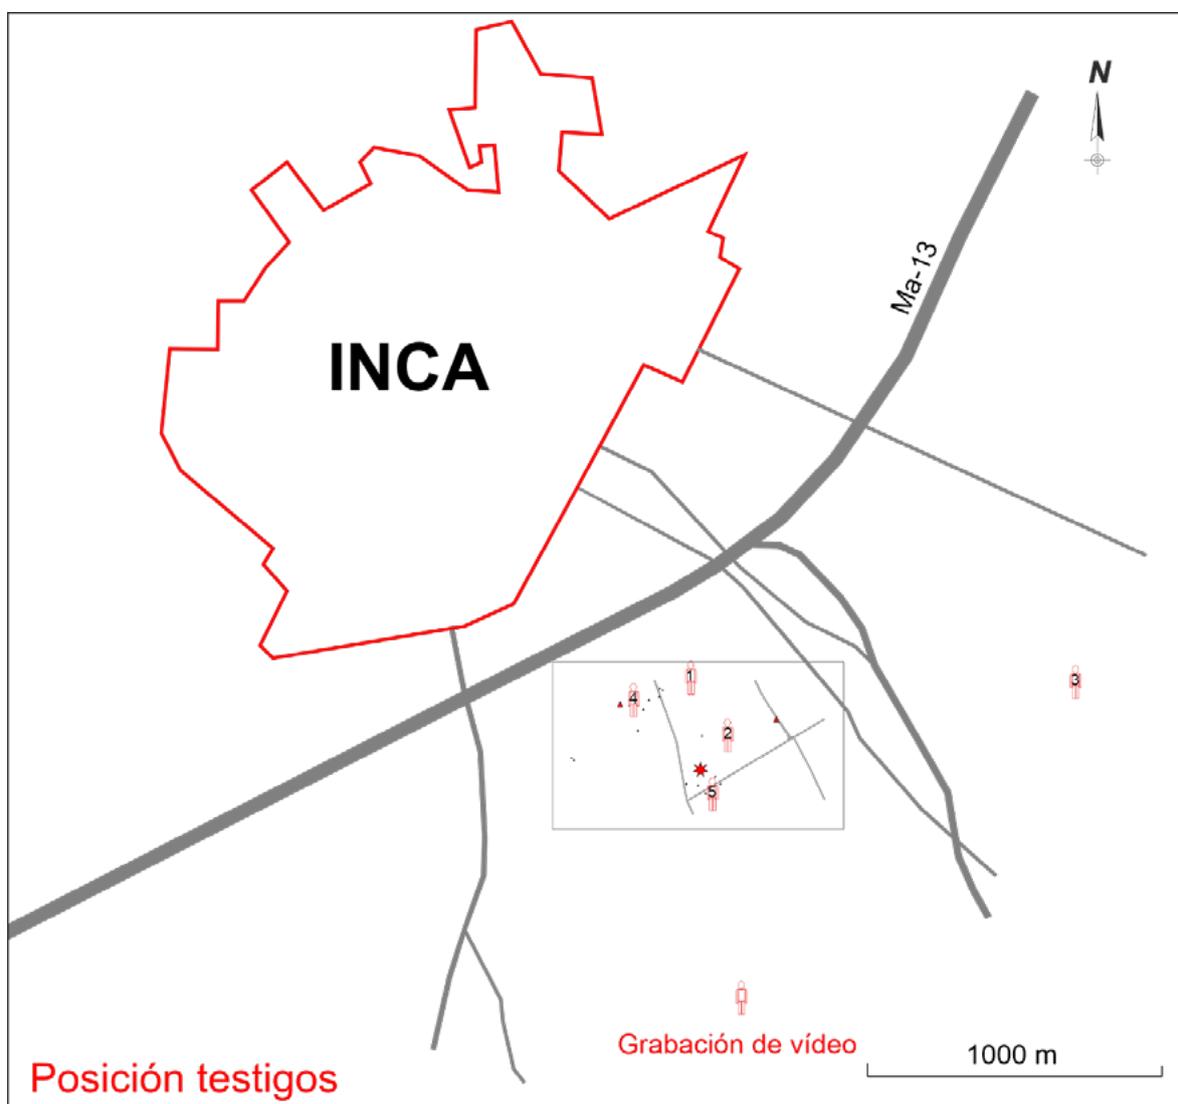
Fig. no. 9 - Map showing the location of the witnesses in relation to the wreckage sites.

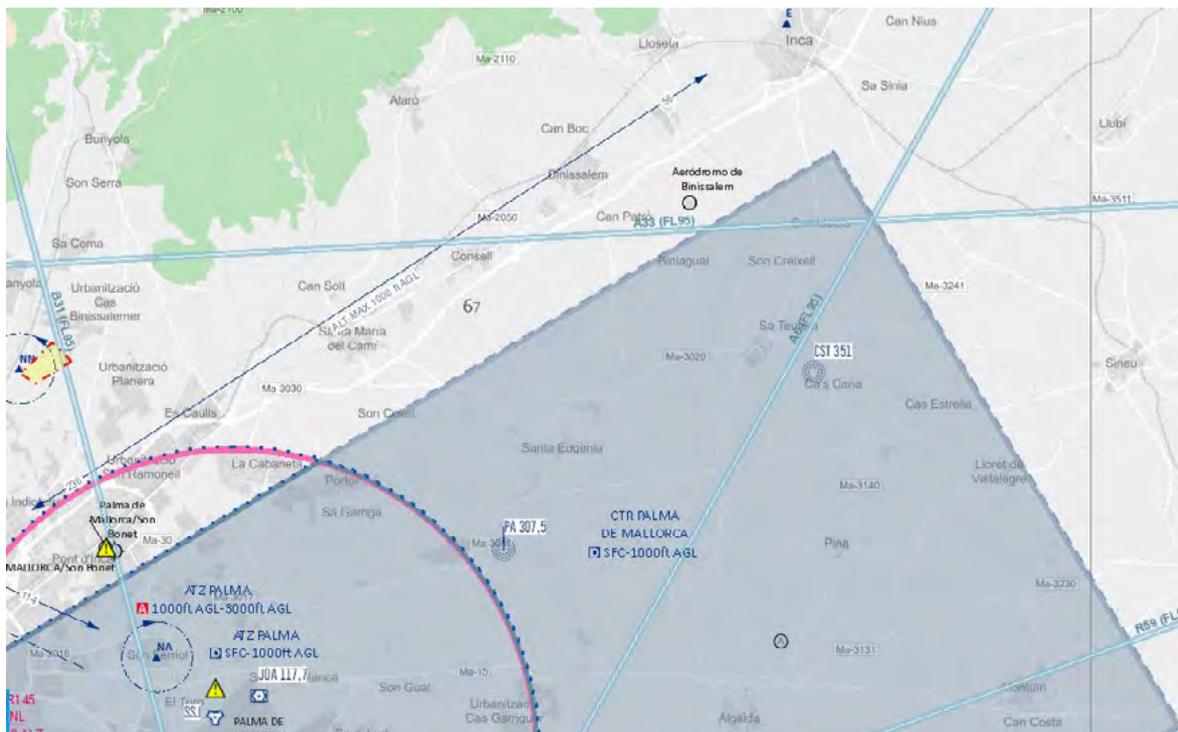
The collision occurred to the SW of the Mallorcan town of Inca, in uncontrolled "G" classified airspace.

Fig. no. 10 - Palma CTR (grey zone) and location of Binissalem Aerodrome

As established by European Regulation SERA.6001, in a class "G" airspace, aircraft are not subject to ATC clearance, separation is not provided between any type of flight and a flight information service is only provided on request.
