CIAIAC

Report A-045/2020

Accident involving an Airbus Helicopters MBB BK117 D-2/H145 aircraft operated by Eliance Helicopter Global Services, registration EC-MJK, on 16 November 2020 in the municipality of Piera (Barcelona, Spain)

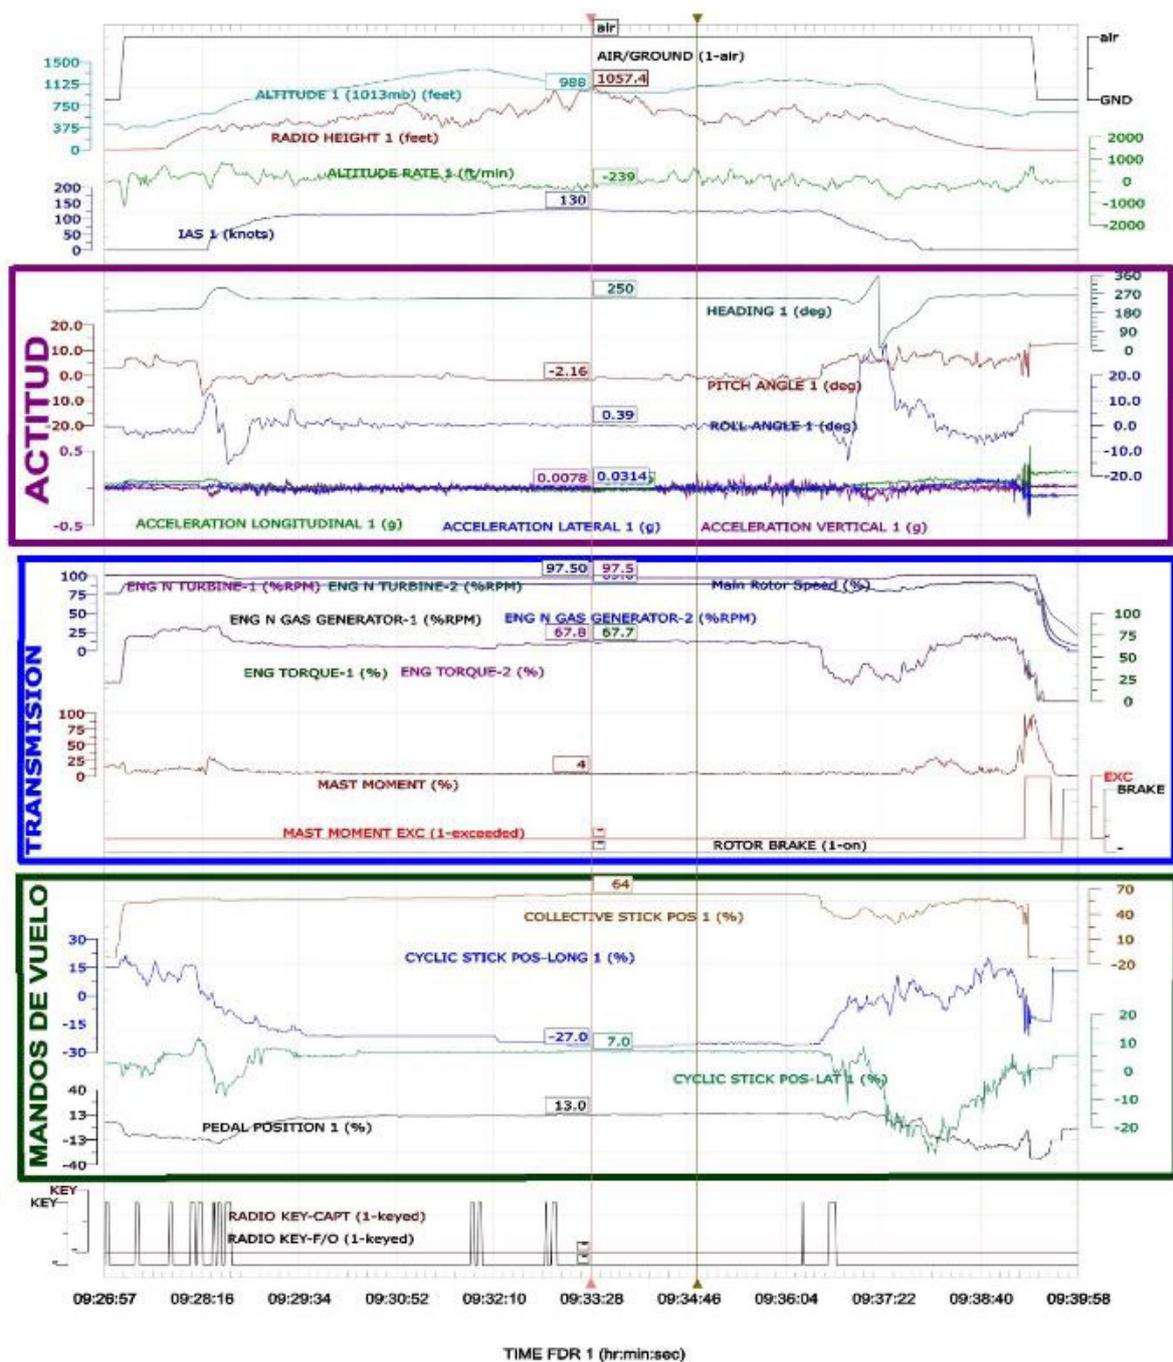
Illustration 7: Full flight parameters

The helicopter then pitched two more times. The pilot kept the cyclic control in an advanced-forward position. The MAST_MOMENT ranged from 70% to 98%. The aircraft slipped backwards. When the pilot lowered the collective to settle the aircraft, one of the main rotor blades struck the helicopter's upper cable cutter (coinciding with the extreme values of the longitudinal, lateral and vertical accelerations), and the noise of the impact can be clearly discerned in the recording from the cockpit voice recorder. The impact causes the aircraft to slip backwards again.

- They immediately stopped the engines and slowed the rotor when its revolutions were at 36%.
