# CIAIAC

## Report A-064/2019

Accident involving a Beechcraft  
BE76, registration EC-INC, at  
La Axarquía Aerodrome (Málaga)  
on 25 November 2019

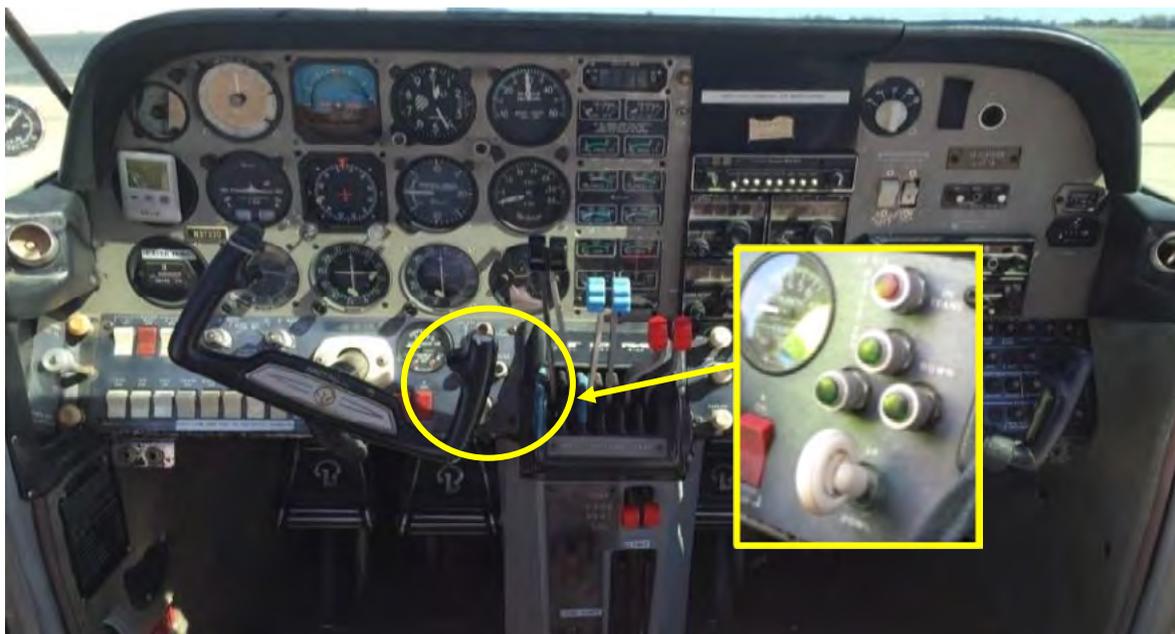
Photograph 2 shows the landing gear lever position and the indicator lights when the landing gear is down and locked in the case of the three lower green lights, and, in the case of the upper red light when it is in transit or an intermediate position.

Photograph 2: Instrument panel of the accident aircraft
