# Technical report IN-005/2021

Incident on 21 February 2021 involving a CESSNA 525 aircraft operated by ProAir Aviation GmbH, registration D-IPOD, at A Coruña Airport (Spain)

### IN-005/2021

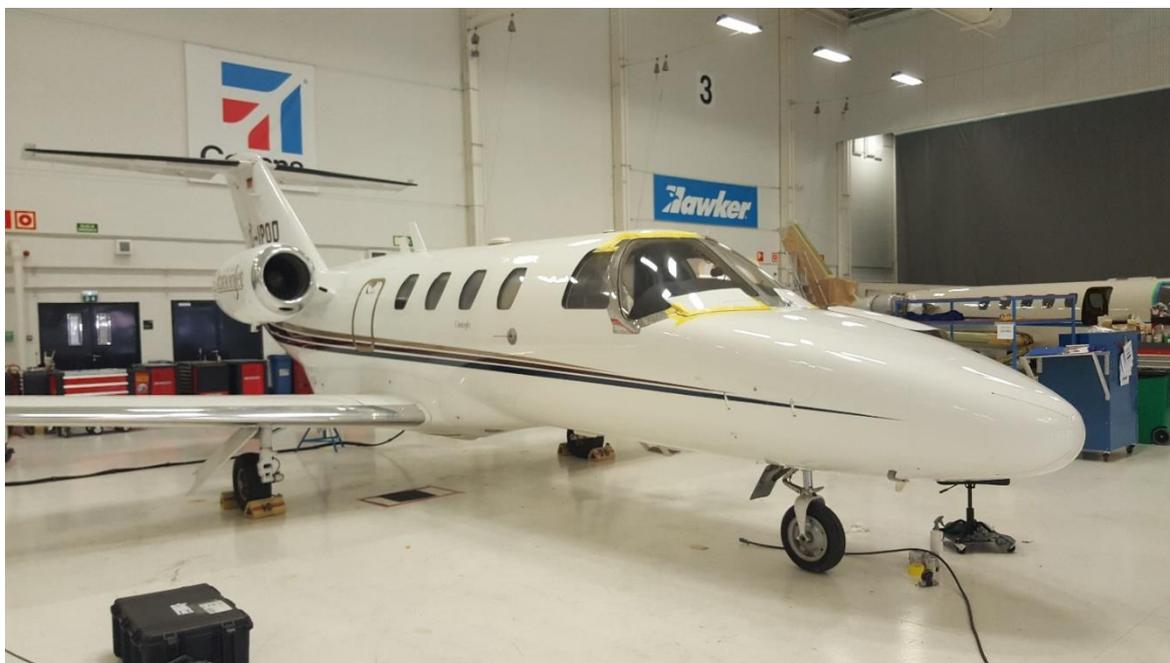
Photograph 1: Aircraft involved in the incident

The aircraft sustained minor damage to the nose landing gear.

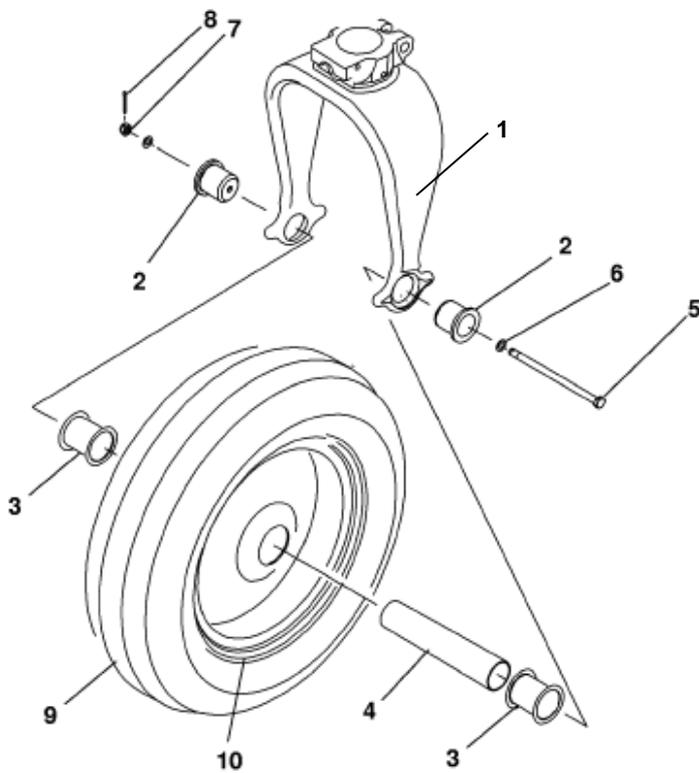
Right - Photograph 6. Damage to the nose wheel fork

The aircraft sustained minor damage as a result of the incident, specifically to the nose landing gear wheel fork.

The damage reported by the aircraft operator was minor and restricted to scratches and small notches on the outer arm of the nose gear fork.
