**COMISIÓN DE  
INVESTIGACIÓN  
DE ACCIDENTES  
E INCIDENTES DE  
AVIACIÓN CIVIL**

## Report IN-006/2020

Accident involving a Boeing 767-375ER aircraft operated by Air Canada, registration C-GHOZ, at Madrid-Adolfo Suárez Airport (Madrid) on 3 February 2020

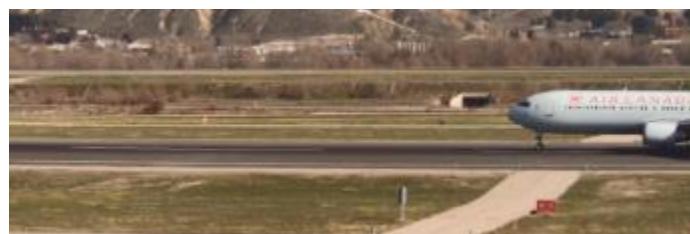
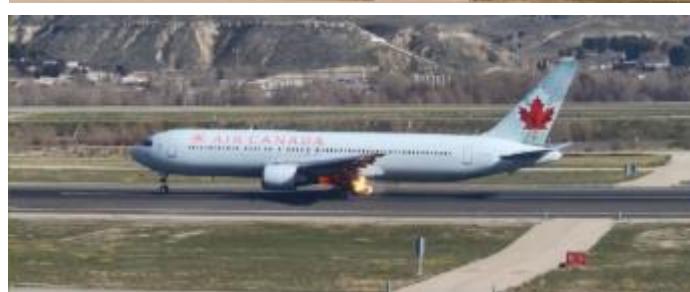
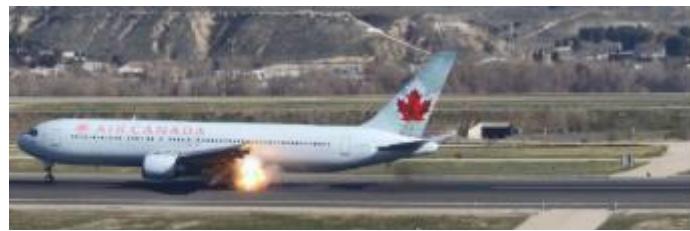
Figure 1. Sequence between 14:58:03 (explosion) and 14:58:05 (rotation begins))

$t=+0$  s    tyre burst and fragments  
ingested by the left engine  
(14:58:03)

$t=+1.2$  s    first flame  
(14:58:04)

$t=+2$  s r    rotation begins (nose  
landing gear sensor in AIR  
mode) and second flame  
(14:58:05)
