Report IN-011/2019

Incident involving a Tecnam
P2006T aircraft, registration
EC-LHB, in Torre de Claramunt
(Barcelona) on 1 March 2019

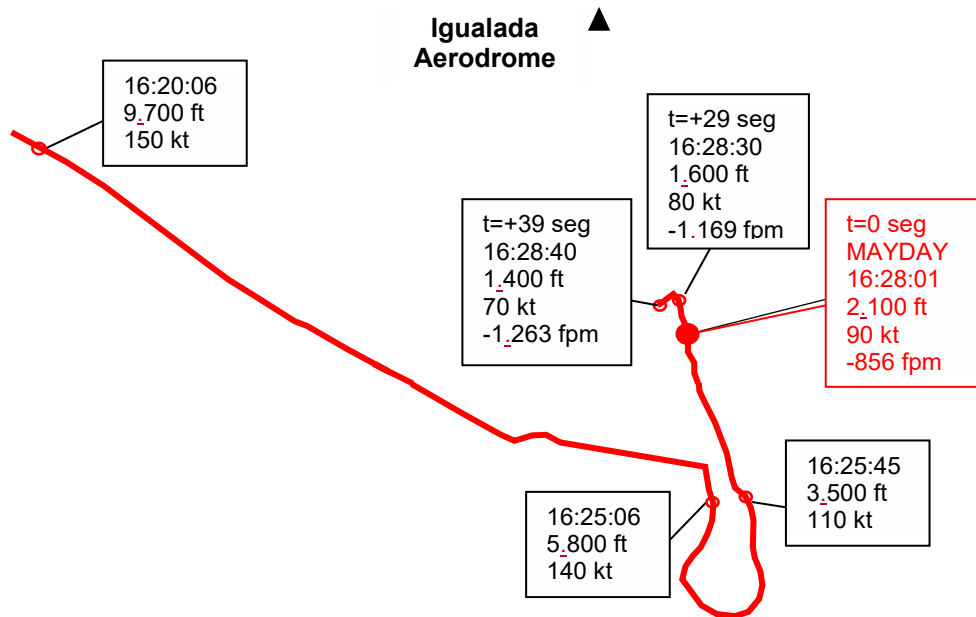
At 16:18:38, the student requested to cancel the IFR plan and to descend to a VFR level. They were initially cleared to 6,000 ft and to descend visually later at the discretion of the pilot. They were approximately 50 km west of the Sabadell Airport and, in keeping with the instructions received, the pilot started a descent from FL100. Figure 3 shows the final 8 min of the flight.

Figure 3. Radar track for the final 8 min of the flight (16:20 to 16:28)

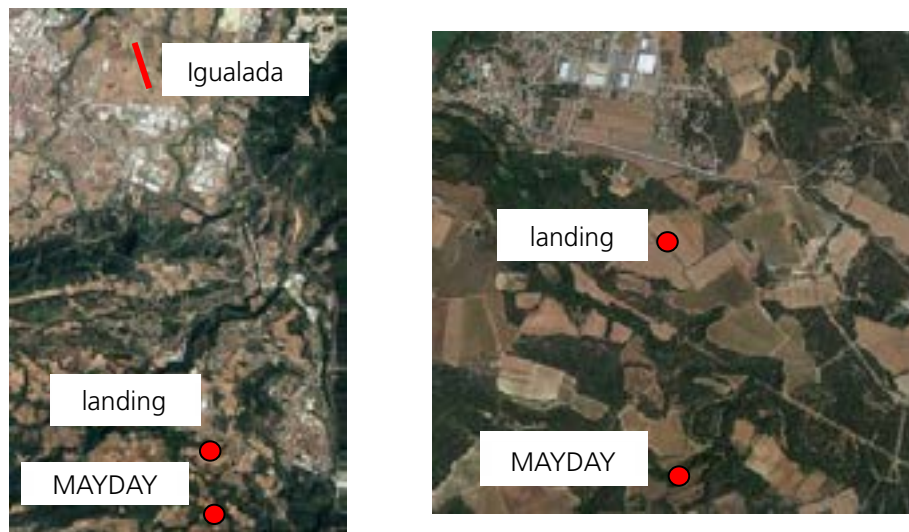
- 1 km southeast of the town of Torre de Claramunt (Barcelona)
- 6 km south of the Igualada aerodrome
- 800 m north of the emergency declaration point

Figure 4. Location of the landing site
