CIAIAC

Report IN-049/2019

Incident involving two Boeing
737-8AS aircraft, registrations
EI-ENH and EI-DYR, on 11 September
2019 at Málaga Airport

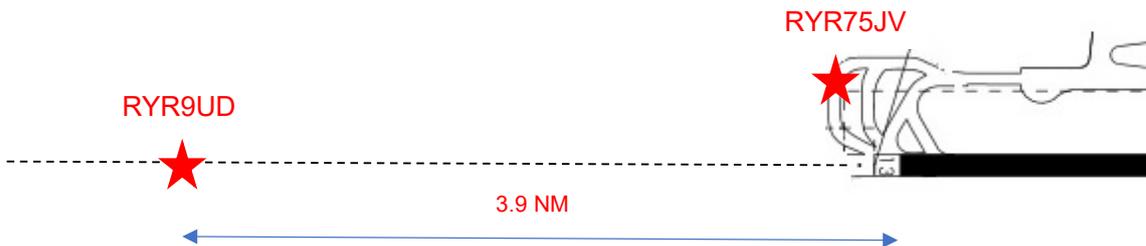
Illustration 4 Position of aircraft at 19:52:27 UTC, RZR75JV (right) and RZR9UD (left)

At 19:52:27 UTC, the trace shows aircraft RYR9UD established on final at 3.9 NM from the threshold of RWY13 with a ground speed of 168 kt. At that moment, the RYR75JV aircraft was at the HN-3 holding point signal.

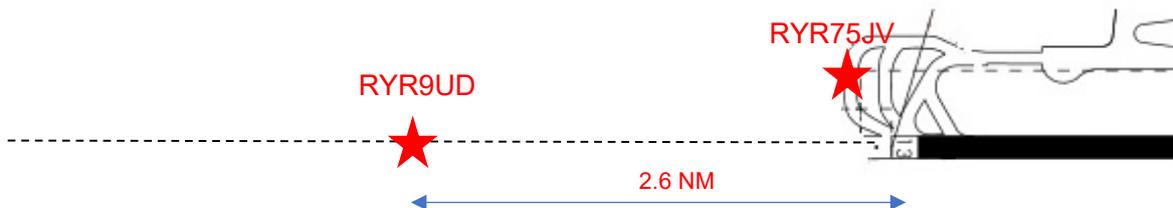
Illustration 5 Position of aircraft at 19:52:58 UTC

At 19:52:58 UTC, the trace shows aircraft RZR9UD established on final at 2.6 NM from the threshold of RWY13. At that moment, the RZR75JV aircraft had just passed the HN3 holding point signal.

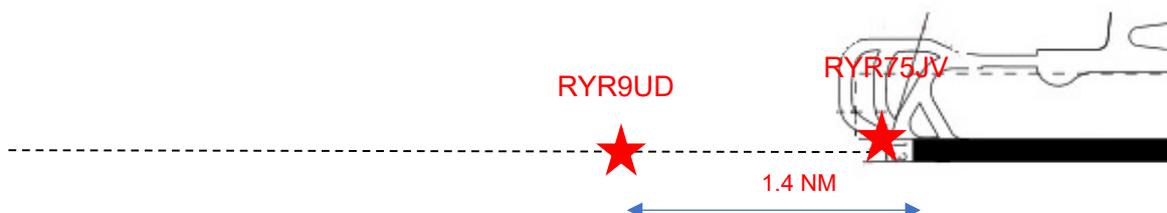
Illustration 6 Position of aircraft at 19:53:29 UTC

At 19:53:29 UTC, the trace shows aircraft RZR9UD established on final at 1.4 NM from the threshold of RWY 13 at an altitude of 500 ft AMSL, and aircraft RZR75JV proceeding to RWY 13, approaching the runway threshold.

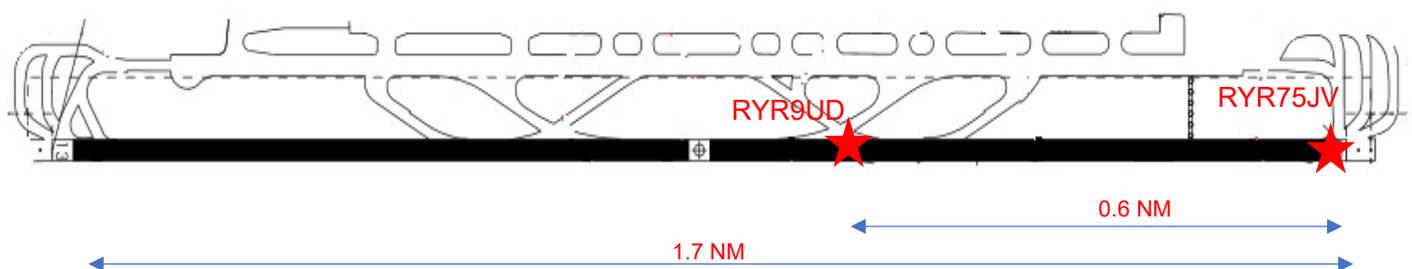
Illustration 12 Position of aircraft at 19:54:35 UTC

At 19:54:35 UTC, the trace shows aircraft RZR9UD decelerating during its landing roll-out on RWY 13, and aircraft RZR75JV on its initial climb, passing the threshold of runway 31 at an altitude of 700 ft AMSL. The distance between the two aircraft was 0.6 NM.

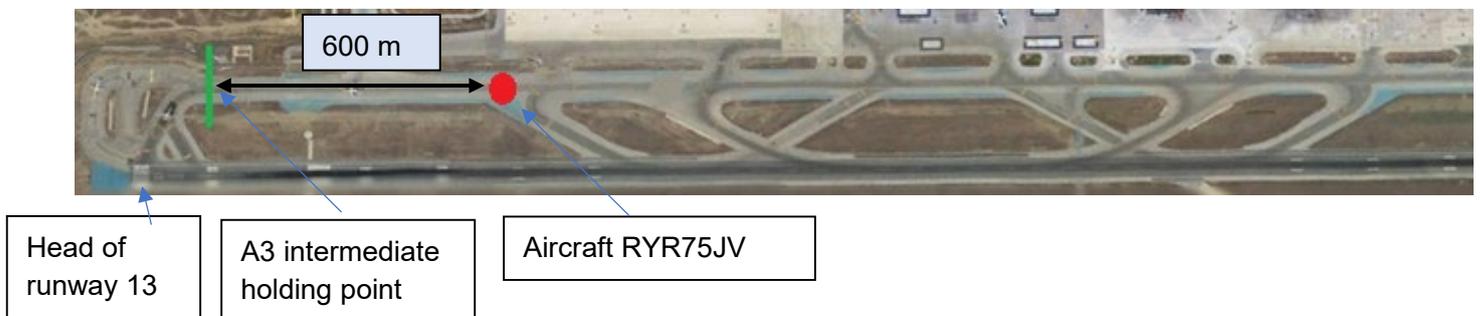
At 19:49:49 UTC, thirty seconds after the aircraft’s last communication with the GMC position, the air traffic controller in the LCL position instructed aircraft RYR75JV to hold short of RWY 13. At that moment, the RYR75JV aircraft was 600 m from the A3 intermediate holding point.

Having not received specific instructions as to which holding point they should go to, the crew chose to taxi to holding point HN-3, which is the holding point furthest from the runway head.

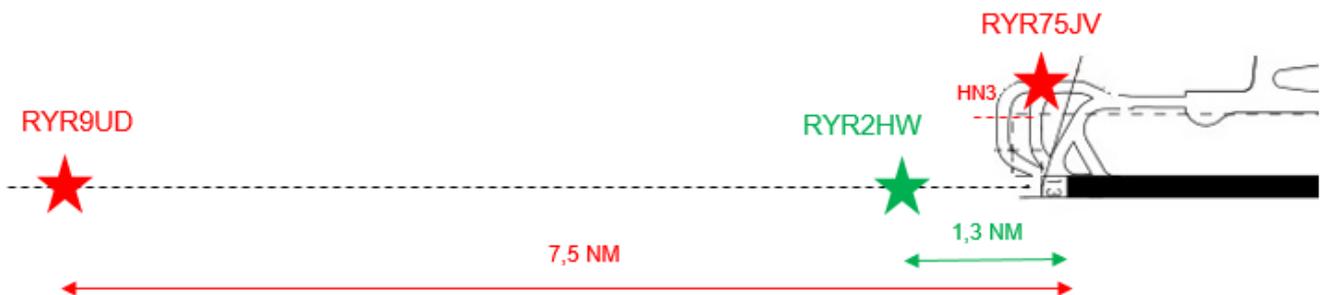
The LCL position controller planned to take advantage of the 6NM gap between two approaches to clear the take-off of the EI-ENH aircraft with callsign RYR75JV. The following image shows the relative positions of the aircraft at 19:51:17 UTC.

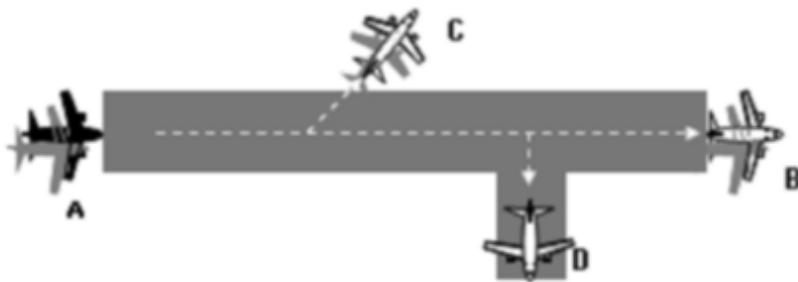
In the incident being analysed, the air traffic controller did not heed any of the three aforementioned instructions or provision 4.5.10.1.1 of the Air Traffic Regulations, which establishes the following:

The landing was authorised when the aircraft was practically above the runway threshold, allowing it to cross said threshold while the outbound aircraft was still on the runway. Moreover, there was no degree of assurance that the regulatory separation could be maintained, as the aircraft on approach was travelling faster than the aircraft on take-off, increasingly reducing the separation between the aircraft. The air traffic controller failed to anticipate the required separation between the aircraft.
