# **MINISTRY OF INFRASTRUCTURE AND TRASPORT**

**Directorate General for Rail and Marine Investigations**

**Fire on Board Ro-Ro Pax *SORRENTO***

**Final Report**

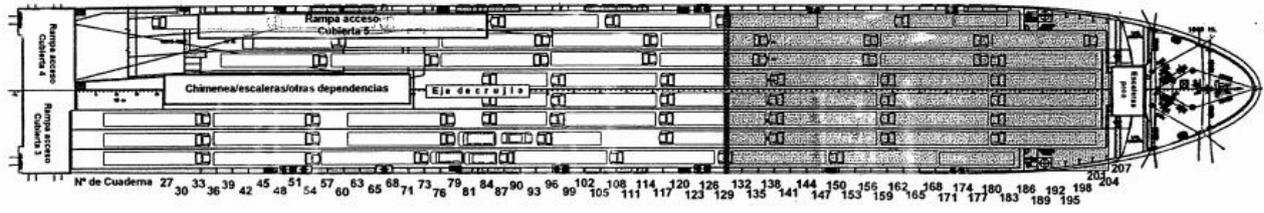
FIGURE 1 POSSIBLE CARGO SITUATION ON DECK 4

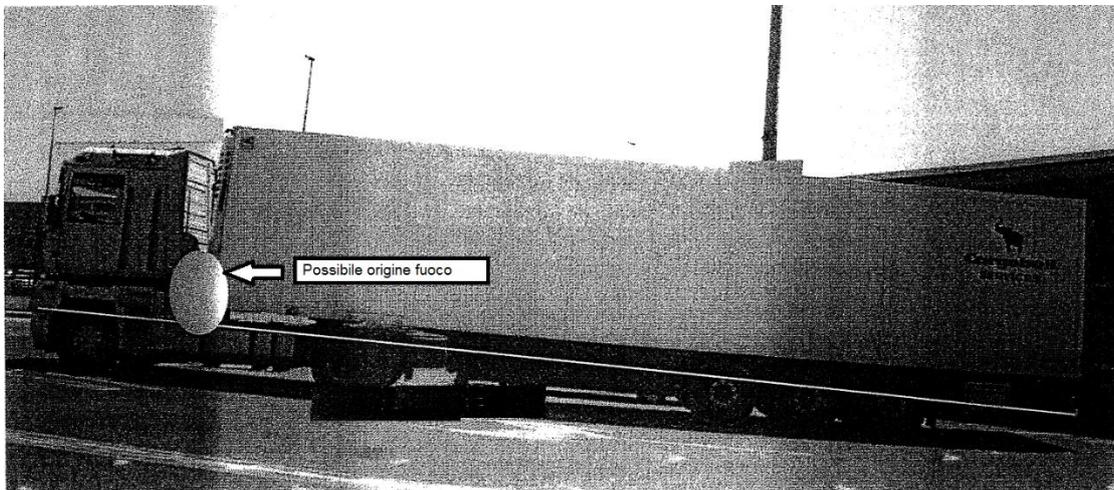
**Photo 9: Similar reefer truck**

With regards to the trailer, from the remains that were found (glass wool, bones and meat) it was possible to understand that it was a refrigerated trailer transporting meat.
