Technical report

ULM A-012/2021

Accident on 12 June 2021, involving a
TECNAM P-92 ECHO aircraft, registration EC-FK6,
operated by Ignagua Center, S.L., at
Casarrubios del Monte Aerodrome (Toledo, Spain)

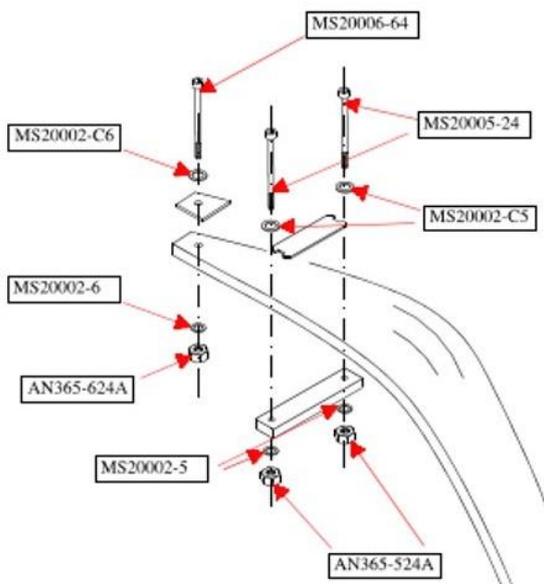
Figure 3. Part numbers of the main landing gear attachment system

The current valid part numbers, quantities and required tightening torques are shown in Figure 3 and the table in Figure 4.

According to the aircraft manufacturer, the use of any bolts other than those recommended may result in vibrations at the landing gear attachment point and cause the nuts to become loose, compromising the connection.

It should be noted that in addition to applying the recommended tightening torques to ensure the correct attachment of the leg to the fuselage, the manufacturer also recommends the nuts be replaced one by one, without applying the final torque until they have all been replaced. Thus, the correct torque should be applied after fitting all the nuts. This practice has been proven to reduce the risk of the main landing gear leg detaching.
