# Technical report

## **IN-007/2018**

Incident involving a Boeing 737-740 aircraft operated by Jet Time A/S, registration OY-JTY, 35 NM north of Gran Canaria Airport (Las Palmas, Spain), on 25 February 2018

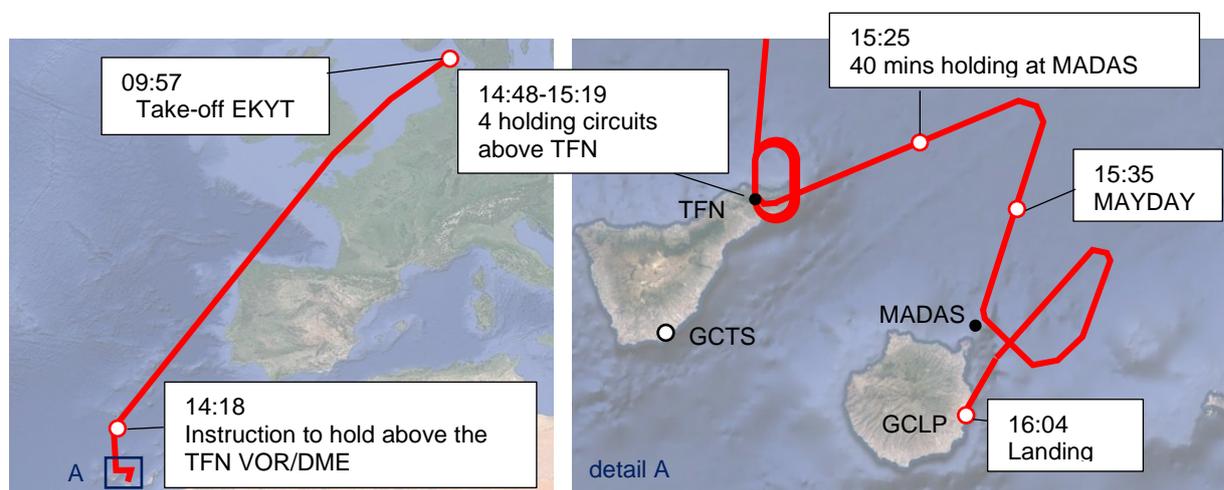
Figure 1. Trajectory

At 14:48, the aircraft arrived at TFN and began to fly a holding pattern. From that moment on, the sequence of events was as follows:

At 09:57, the aircraft rotated for take-off. At 14:16, the aircraft was transferred to the Canary Islands ACC. Two minutes later, at 14:18, it was instructed to fly a holding pattern above the TFN VOR/DME (hereinafter TFN), where four other aircraft were already holding.
