## Technical report S-17/2012

# Investigation of the collision of vessel BESIKTAS PERA against the pier during the docking manoeuvre at the port of Valencia on the 22<sup>nd</sup> of October 2011.

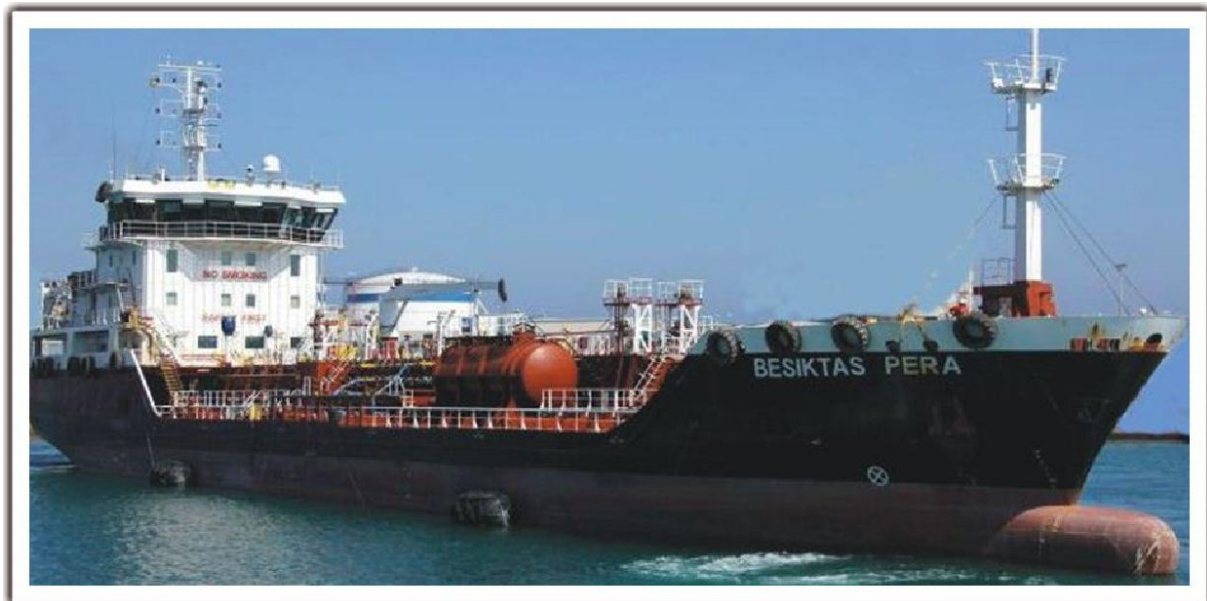
Figure 2. Vessel BESIKTAS PERA

Regarding the main characteristics of the vessel, the following are noted: She has a total length of 98.71 m, a breadth of 14.1 m, a depth of 7.2 m, a maximum draught of 5.8 m, a gross tonnage (GT) of 2,974, a displacement of 5,979 t and deadweight of 4,121 t.
